Manhole Inspection Summary

Manhole # S1900_026MH

Insp Date: **7/5/07 10:32 AM**

Location Address: **2004 BRYANT-WHITTIER**

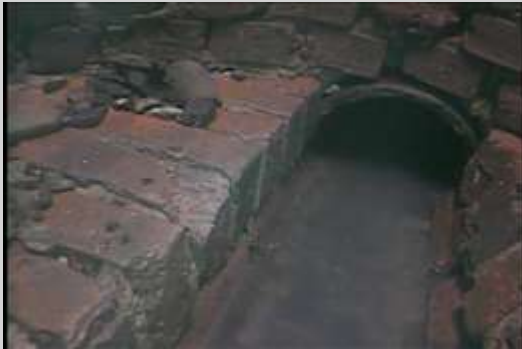
12 O'Clock Outflow

8 in. Circular Gravity Sewer
Pipe Out @ 12 O'Clock

Pipe Height: **7.2** (in.) Rod and Bar (Angled)
Pipe Material: **Clay** ☐ Pipe Lined
Invert Depth: **7.04** (ft.) Flow Characteristics: **Slow**
Deposits: ☒ None ☐ Mud ☐ Sludge ☐ **Debris** ☐ Grease
Silt Depth: (in.) Deposits Extent:
Infiltration: **None** Pipe Seal Cond: **Sound**

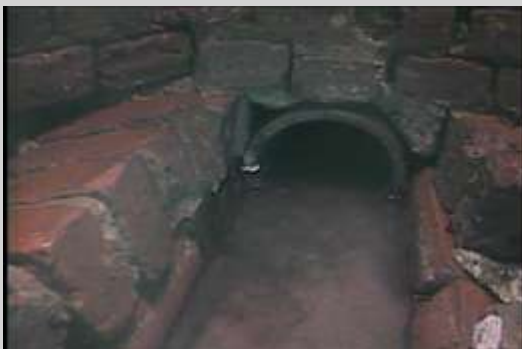
3 O'Clock Inflow

6 in. Circular Gravity Sewer
Pipe In @ 3 O'Clock

Pipe Height: **6** (in.) Rod and Bar (Angled)
Pipe Material: **Clay** ☐ Pipe Lined
Invert Depth: **6.92** (ft.) Flow Characteristics: **Slow**
Deposits: ☒ None ☐ Mud ☐ Sludge ☐ **Debris** ☐ Grease
Silt Depth: (in.) Deposits Extent:
Infiltration: **None** Pipe Seal Cond: **Sound**
